# **“RESTORING, MAINTAINING, AND REPAIRING STAINED GLASS WINDOWS”**

Course Number: MSP1909

Company Name: **BOVARD STUDIO, INC.**

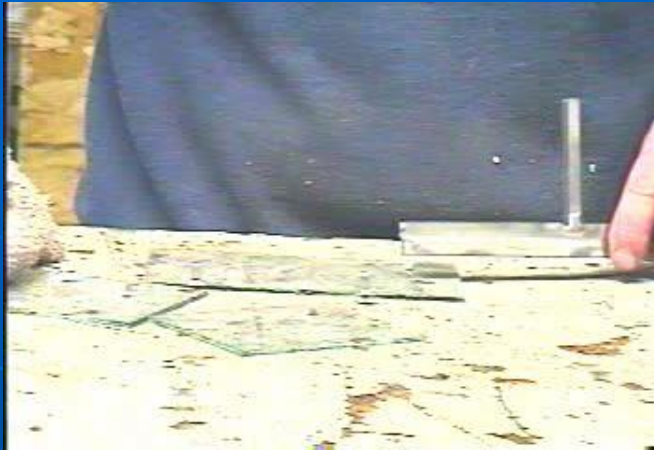
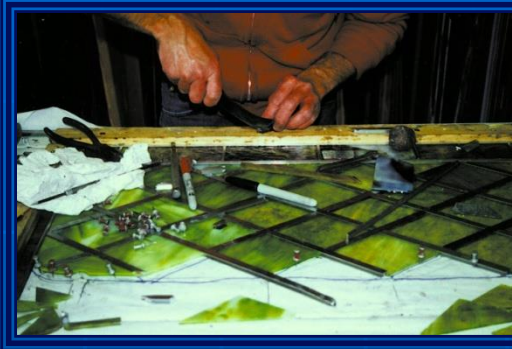
# STRUCTURAL ELEMENTS AND TECHNIQUE

- Small straight rows of rectangular or square glass panes and diamond patterns are prone to bulging, unless they are fabricated into a special woven lead matrix tucked and soldered to the heart of the lead came
- Improperly designed exterior glazing systems lead to premature failure

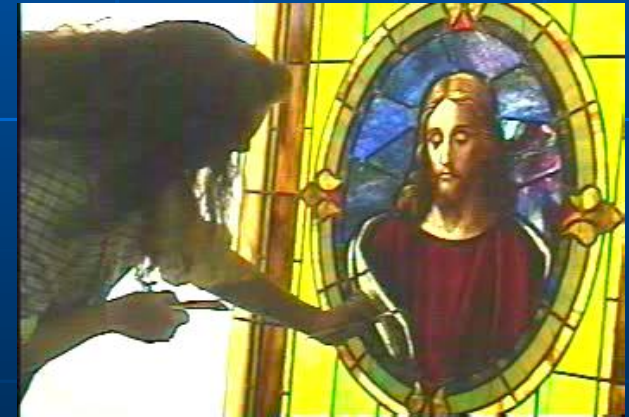
- Paint failure from improper kiln firing of glass, unstable formulas, or washing stained glass windows with acid based cleaners such as vinegar

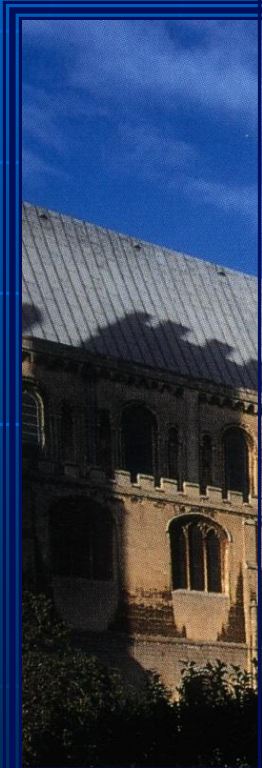
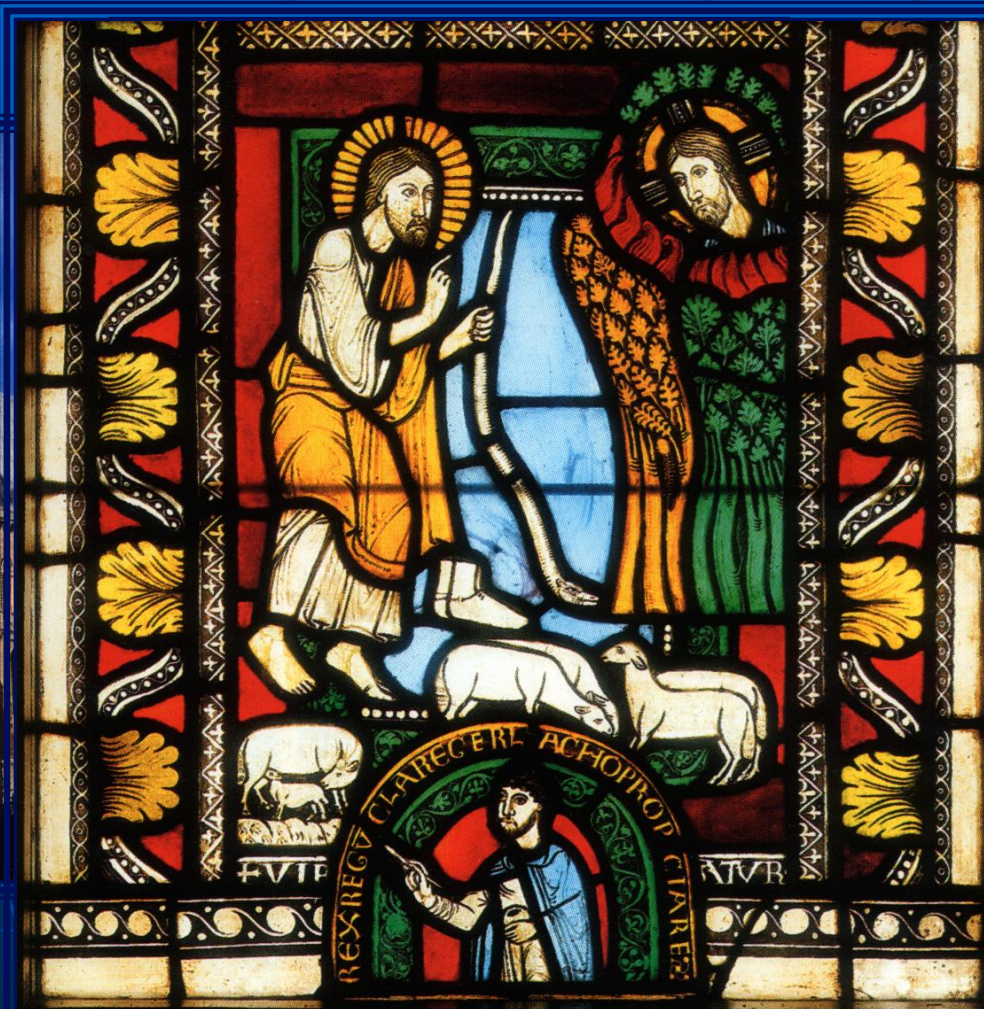
## Lead Came

Many American stained glass windows through the 1950's were made with pure drawn or milled lead. This lead usually lasts 70 to 100 years before serious metal fatigue sets in. Drawing or milling can stress the pure lead.

Europe's great cathedral stained glass windows were made with cast lead with impurities (trace elements). Some of the lead in these stained glass windows lasted much longer than those made with pure drawn or milled lead.

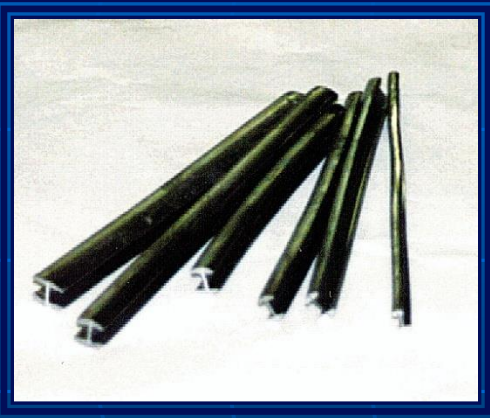
Today we call some of these impurities alloys (tin antimony, silver, copper). We add them on purpose. We extrude our lead. Pure drawn or milled lead has an elongated molecular construction, which results in lead that is less subjected to expansion. Extruded lead has a greater density of construction and is subject to greater expansion than pure drawn or milled lead; therefore, it must be stretched prior to use in a stained glass window to prevent premature bulging.

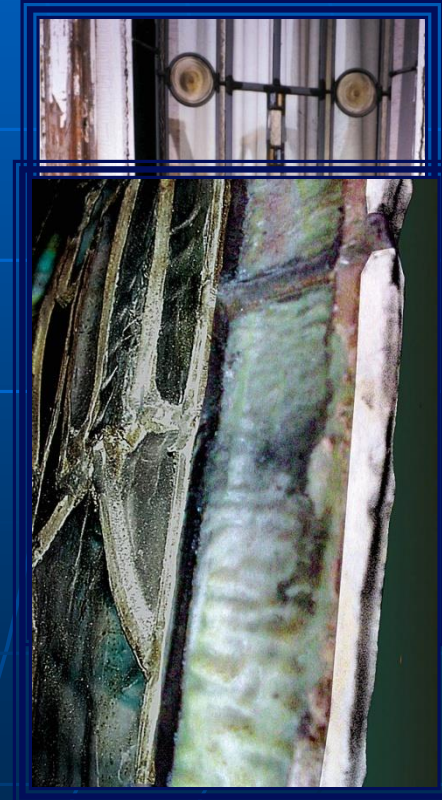
### Symptoms of failure:

- Cracked and broken solder joints
- White powder on the surface of the lead (oxidation)
- Cracks in the surface of the lead came
- Expansion and contraction cycles can cause deflection of the flute...(bulging)
- Serious deterioration of glass painting

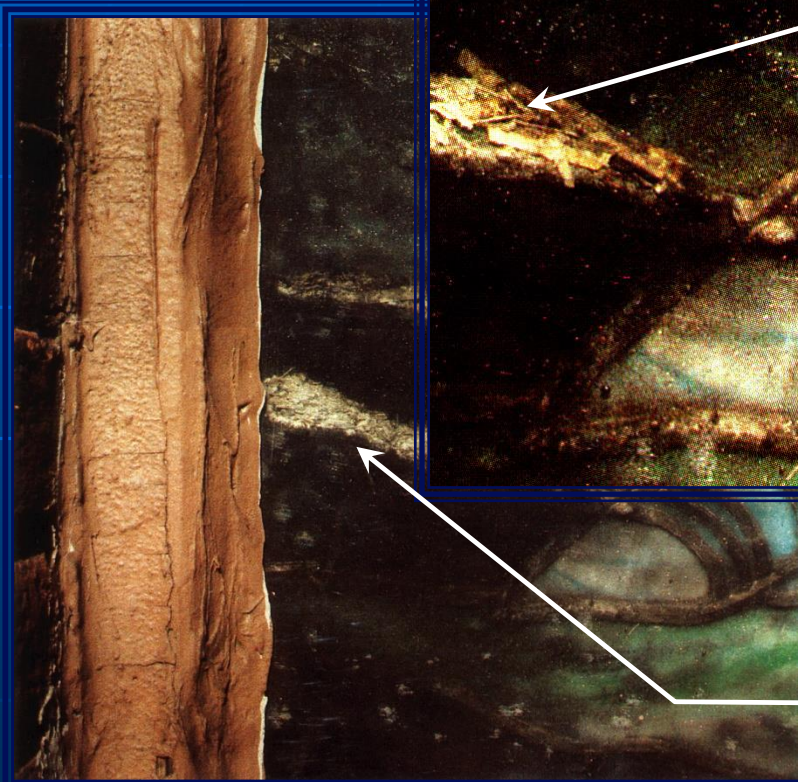
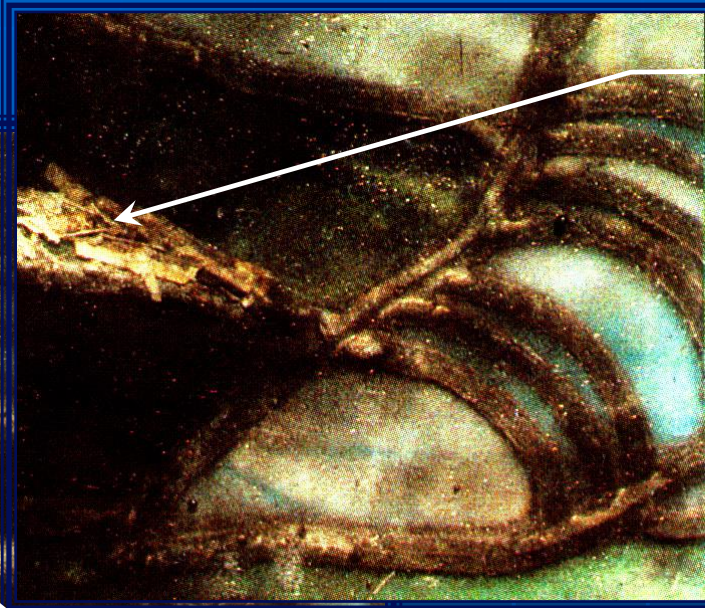
**This damage is from improperly designed and installed protective and exterior glazing systems**

Condensation moves from inside the stained glass window to the space between the stained glass window and protective covering. Bacteria grows in the hygroscopic dust, secretes acid, attacks wood, metal, glass, etc.

The white smudge at the left center of this panel used to be lead came. When the unvented protective glazing was installed, it was placed flush against the stained glass. In cold weather, water condensation accumulated in the air space and oxidized the lead to powder.

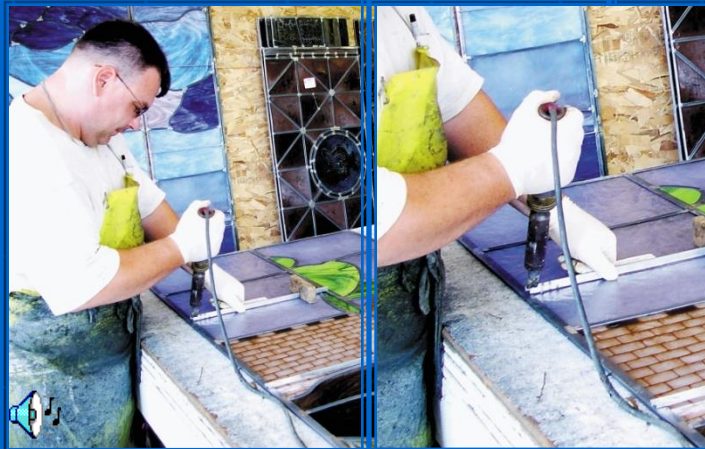
# RELEADING

- Releading is the disassembly, cleaning, and rebuilding the stained glass window with an all new lead matrix, conserving the original stained glass.

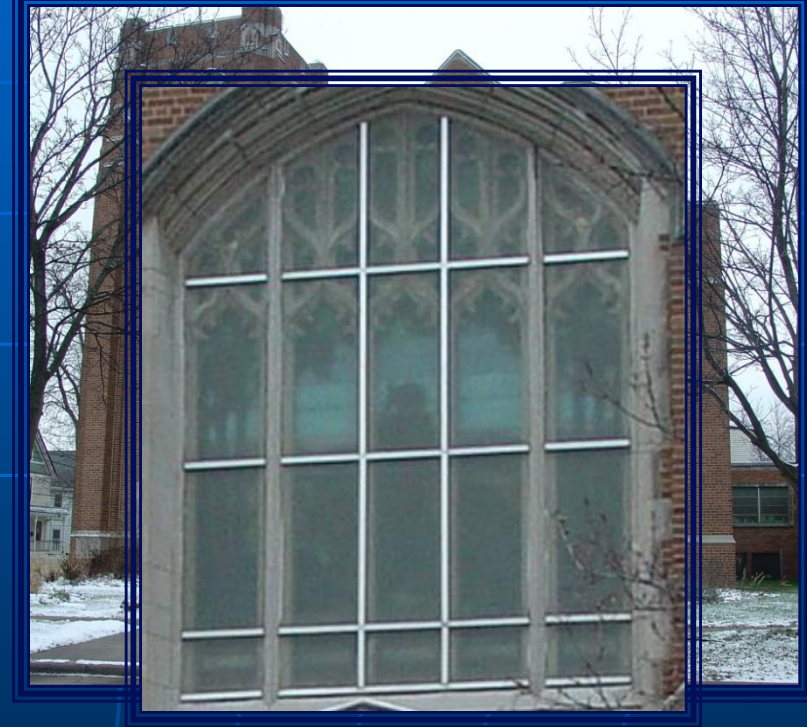
## NATIONAL PRESERVATION STUDY

More damage has probably been done to stained glass windows from improperly designed exterior glazing, or protective covering systems than from all the fires, vandalism, and storm damage combined. Poorly designed protective covering systems also detract from the architectural integrity and beauty of the building.

A definitive engineering study on protective covering, June 30, 1996 for National Preservation Center, Natchitoches, Louisiana, shows stained glass protective covering systems need 1 square inch of venting for every 16 square feet of stained glass.

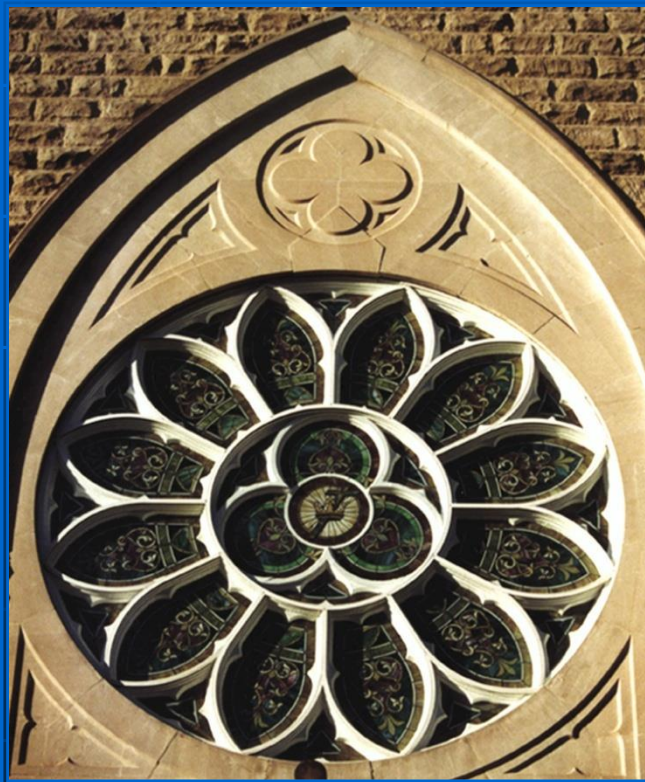
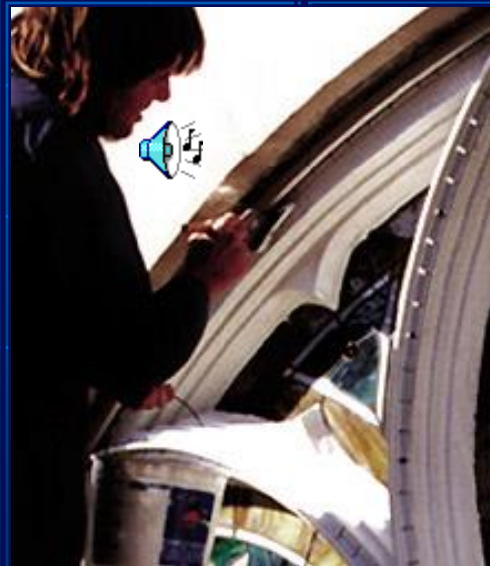
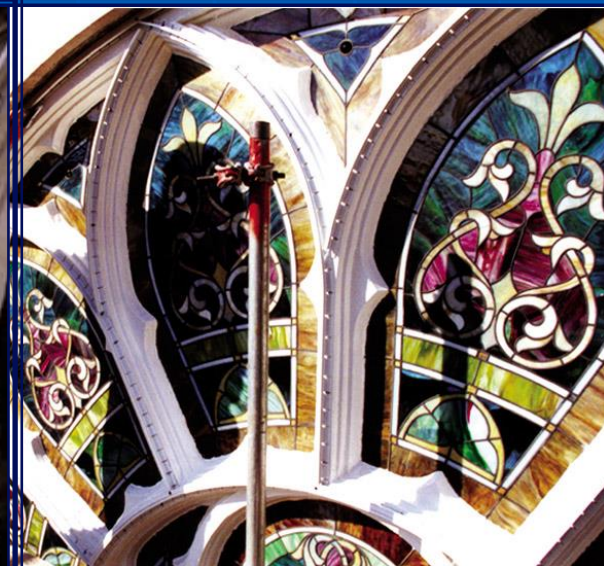
**Above and left:** First United Methodist Church, Iowa City, Iowa installation of the protective covering framing bent to match the original wooden stained glass window frame.

It is important to design the protective covering with proper venting for conservation of the stained glass window and to compliment the window frame to preserve the architectural integrity and beauty of the building.

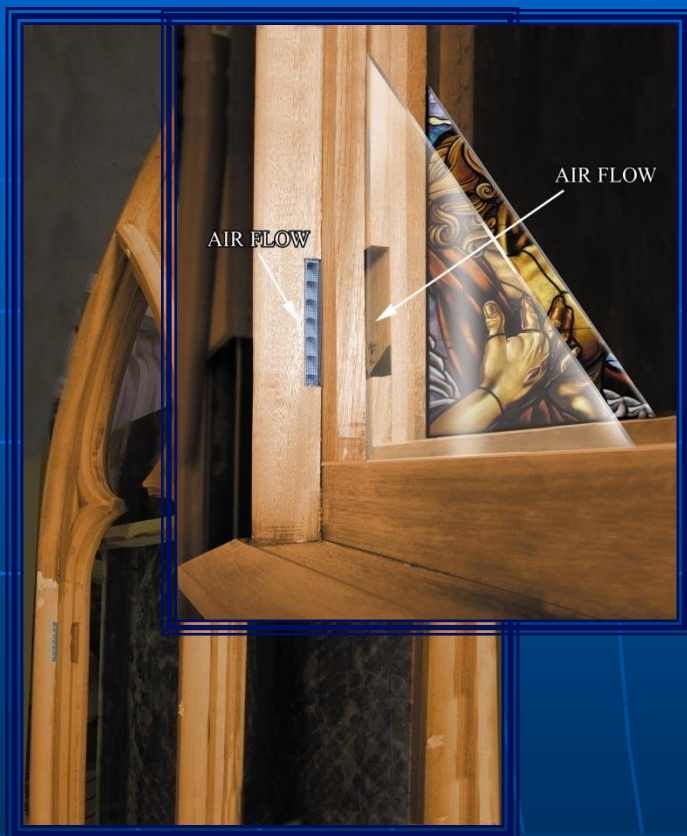
Above: Air flow with bug screen and rain guard Precision Flow® ventilation systems in our new wood frames.

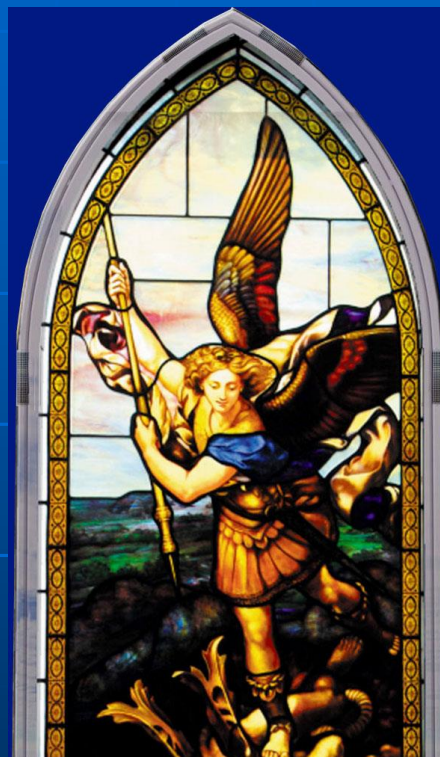
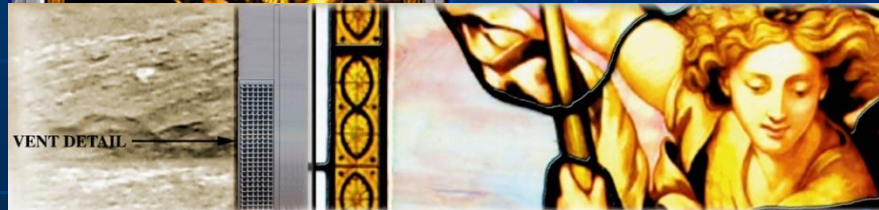
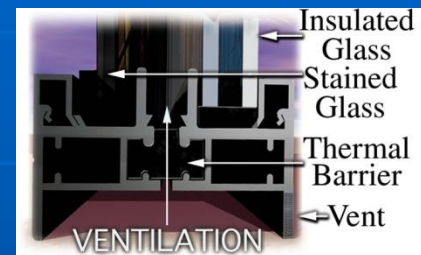
Above: Our Precision Flow® aluminum thermal barrier framing system designed to hold stained glass windows and insulated glass units.

**U.S. Patent #7,607,267 B2**

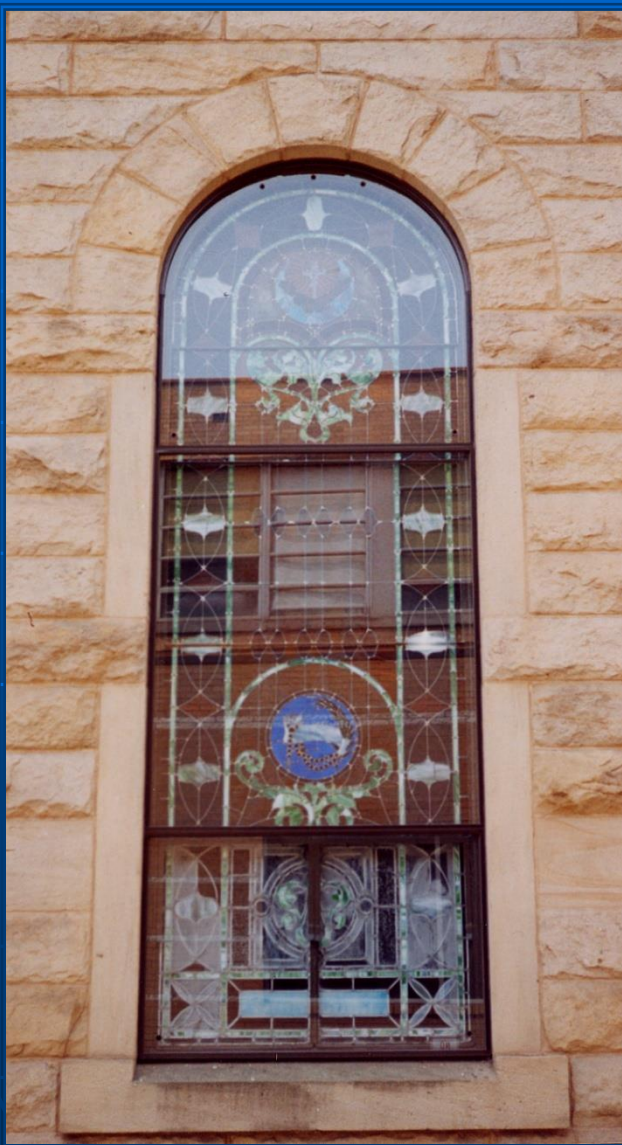
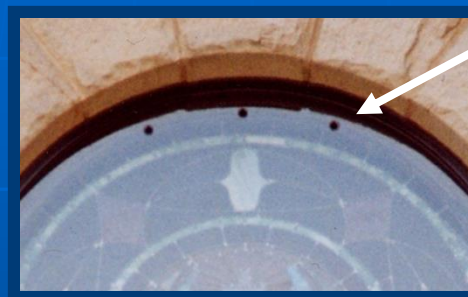
Vent with bug screen and rain guard added.

- You add ventilation to your existing protective glazing system.
- Replace loose sealant as required.
- Clean glass or plastic with appropriate cleaners.
- Retain weep system at base of protective covering.

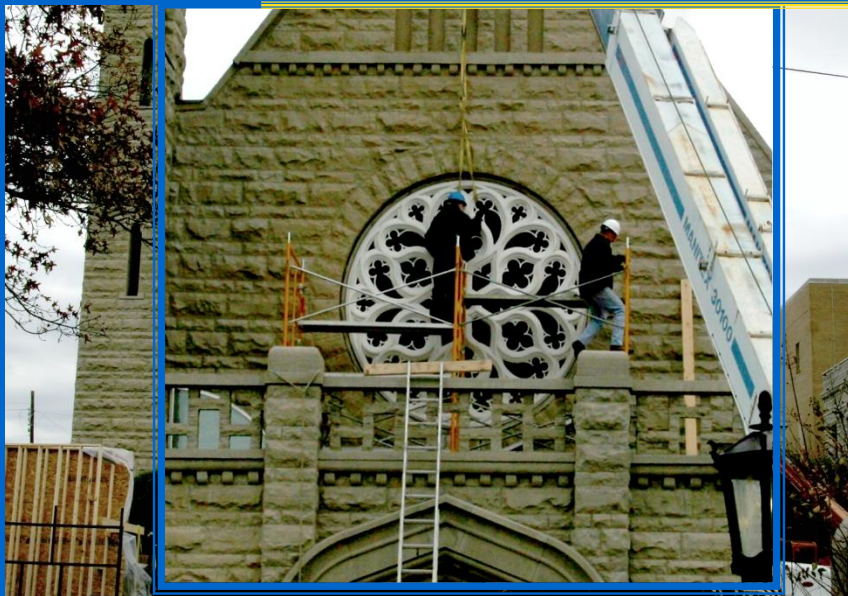
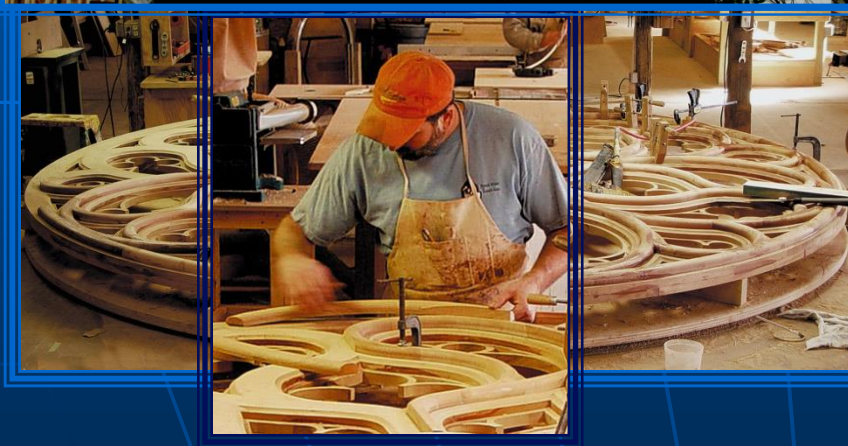
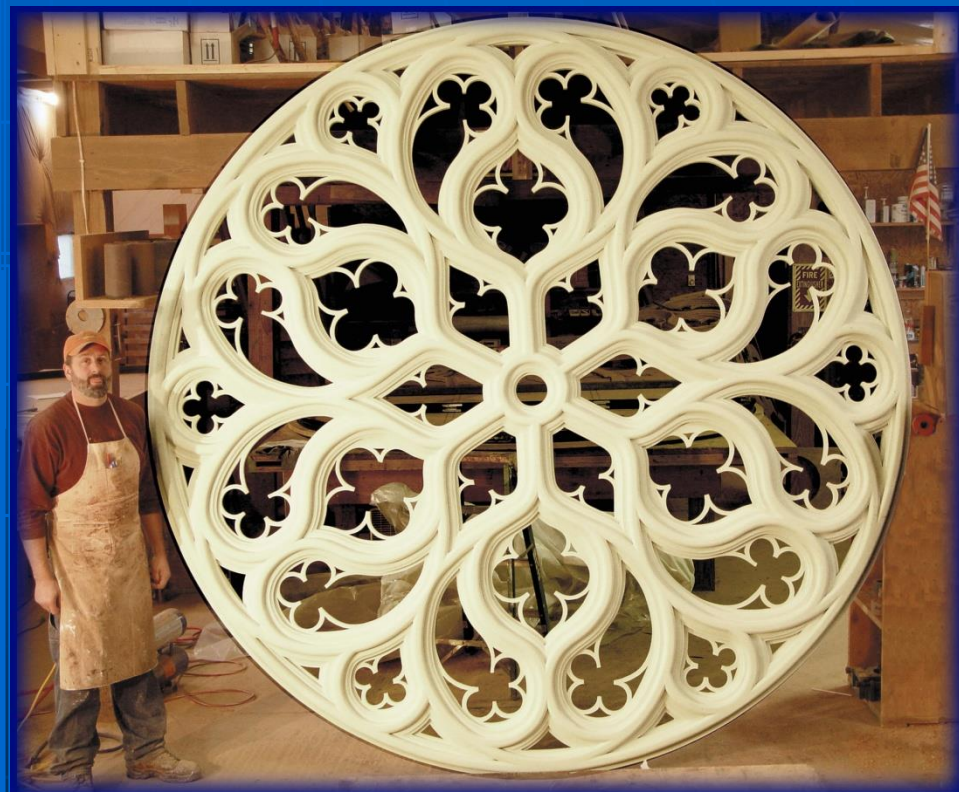
## WOOD FRAMES

**New and replacement frames should be made from a mahogany type of wood, the heart wood of eastern white pine or equivalent 100 year rot resistant wood.**

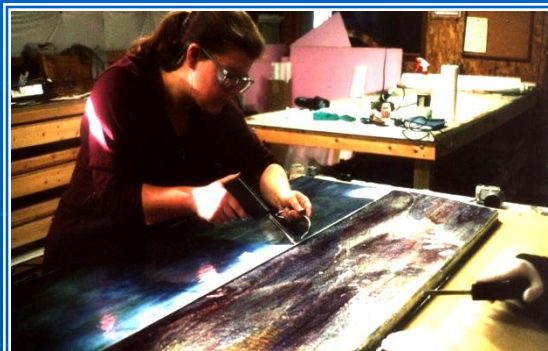
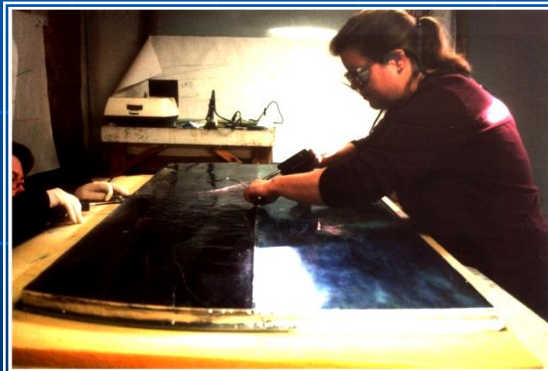
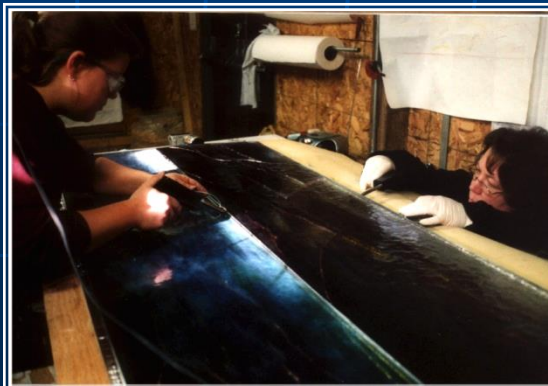
- Tiffany window with 7 layers of glass requires
- Use Ph neutral soap such as Triton X or Orvis horse
- ✓ Disassembling the
- Never use a cleaner with vinegar (attacks glass paint) or ammonia (in the long term corrodes lead)
- ✓ ingredients
- ✓ Reassembly

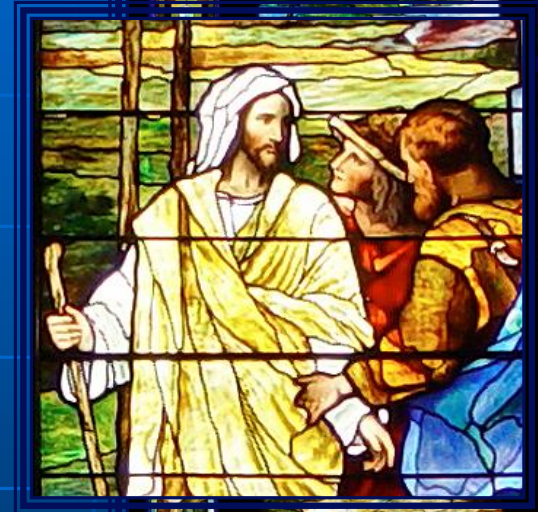
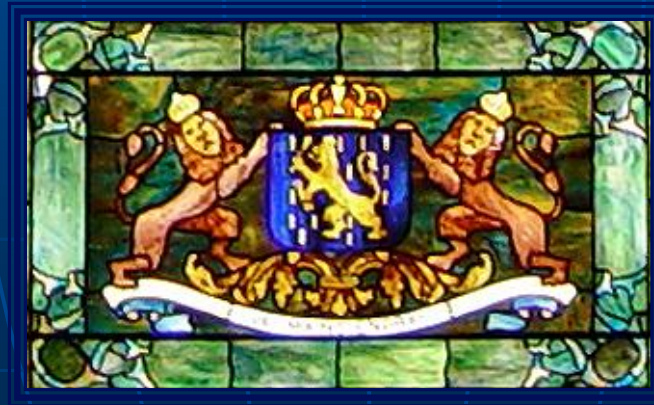
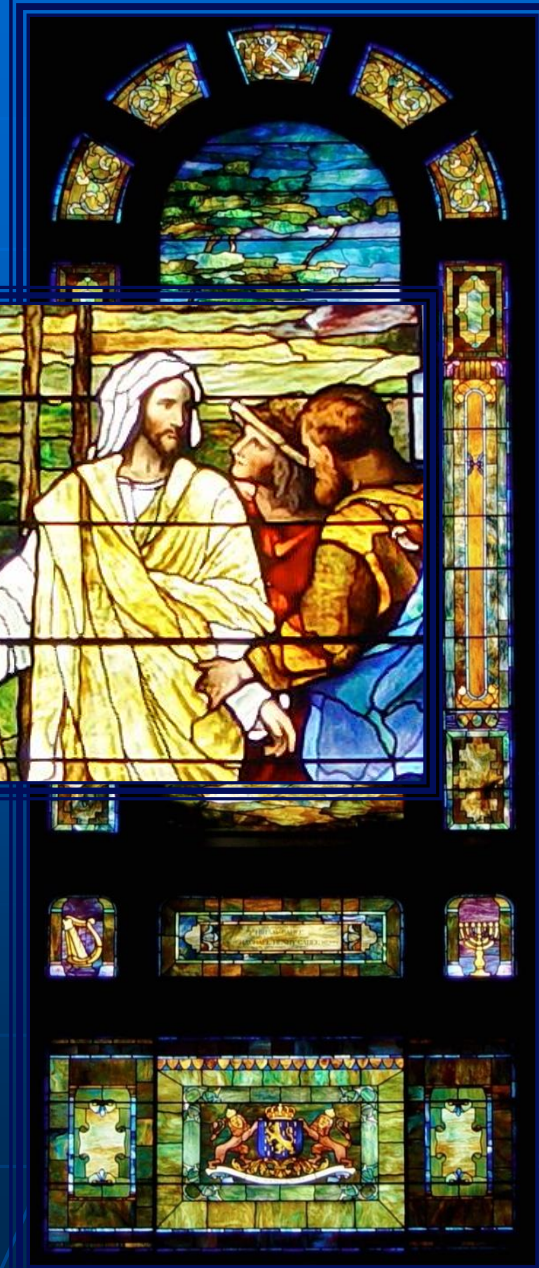
## FRAME & PANEL STRUCTURE MAINTENANCE & REPAIR

- Reputty where putty on T-bars or window frame is loose or missing.
- Keep frames rust free and painted.
- Replace or restore rotted wood.
- Replace loose or missing glazing cement.
- Keep reinforcing bars attached to the stained glass window.

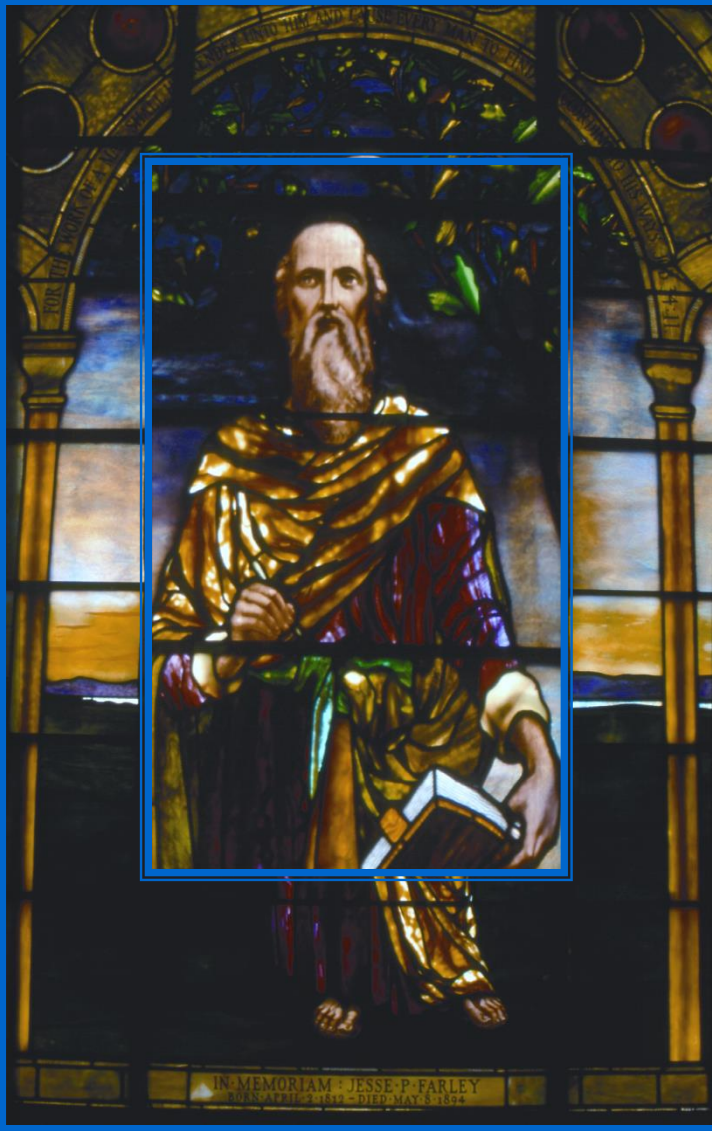
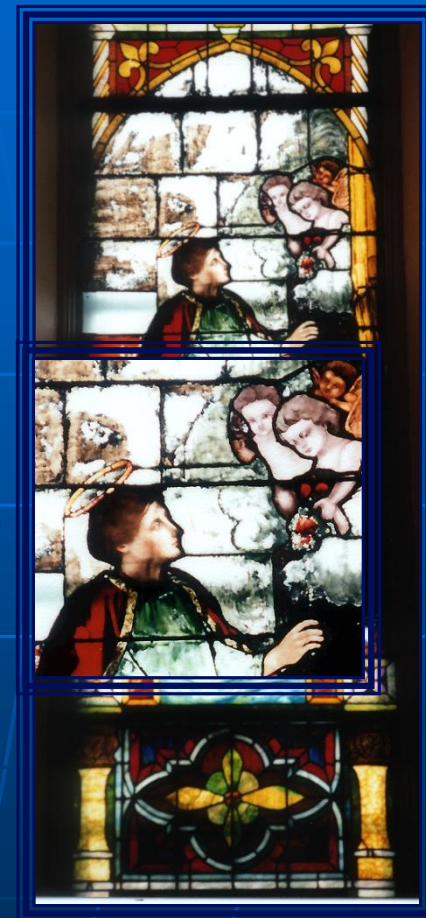
# STAINED GLASS MAINTENANCE & REPAIR

- Replace broken and missing stained glass panes
- Repair cracked panes
- Reattach loose reinforcing systems
- Recement stained glass window
- Touch up deteriorated sections of glass painting in place with cold paint
- Flatten and shore up bulged areas in a stained glass window when the lead came is in good condition

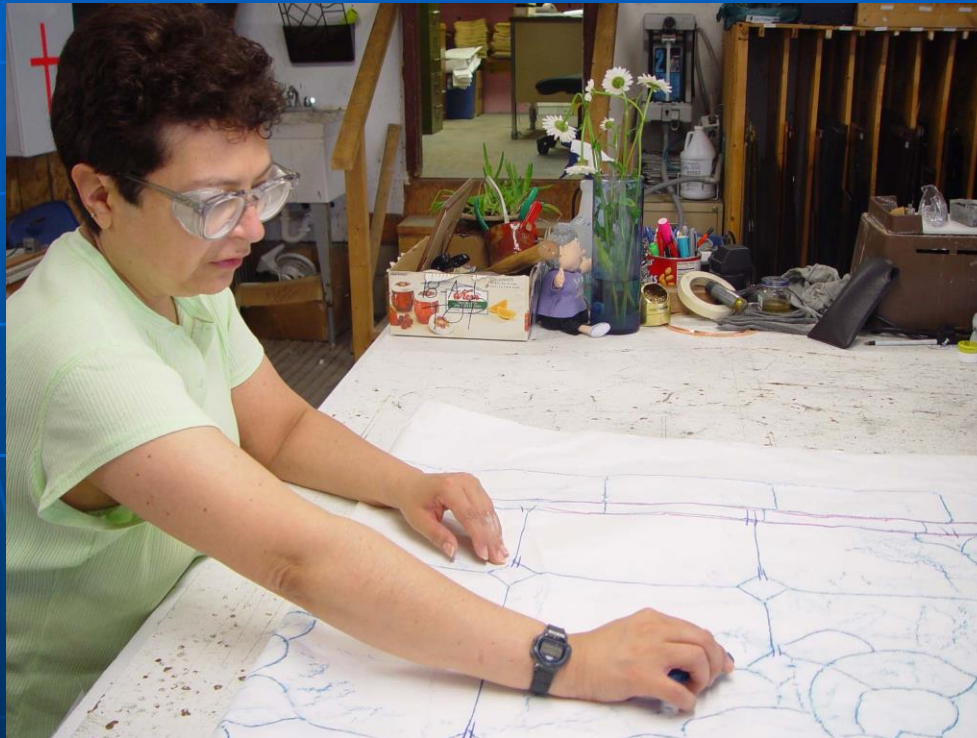
# DOCUMENTATION

- **Photographing the windows**
- **Measuring panel sizes**
- **Measuring rebar placement**
- **Determining lead sizes**
- **Taking glass samples**
- **Selecting glass**
- **Making rubbings**
- **Making material list**

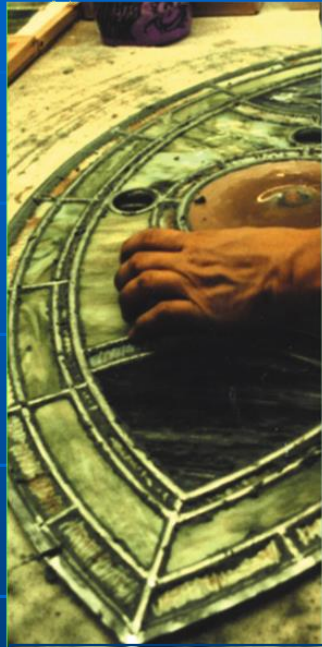
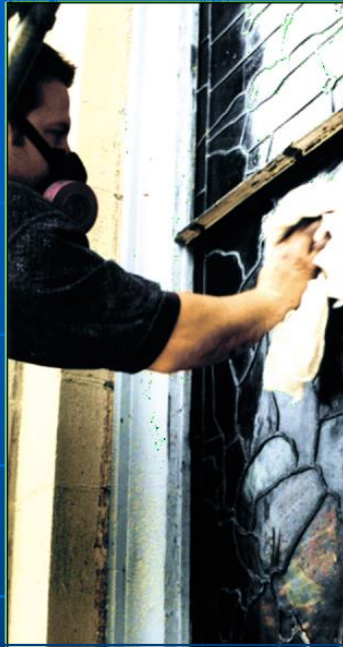
LEFT: Glaziers cementing a panel from St. Luke's Tiffany "Job" stained glass window.

Right: A Craftperson performs the final cleaning after reinstallation of Tiffany's "Job" window at St. Luke's United Methodist Church in Dubuque, Iowa.

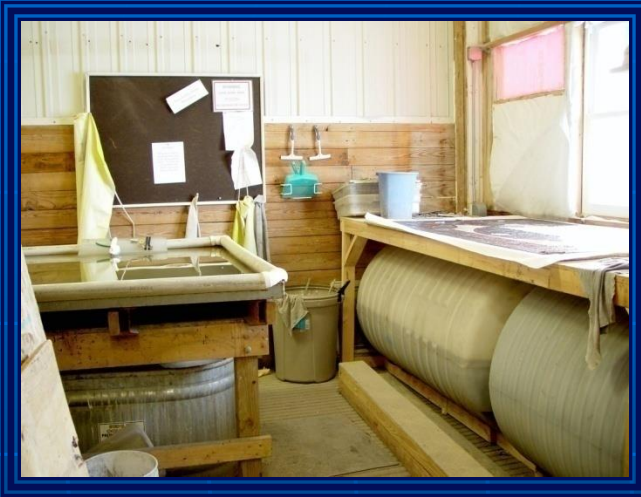
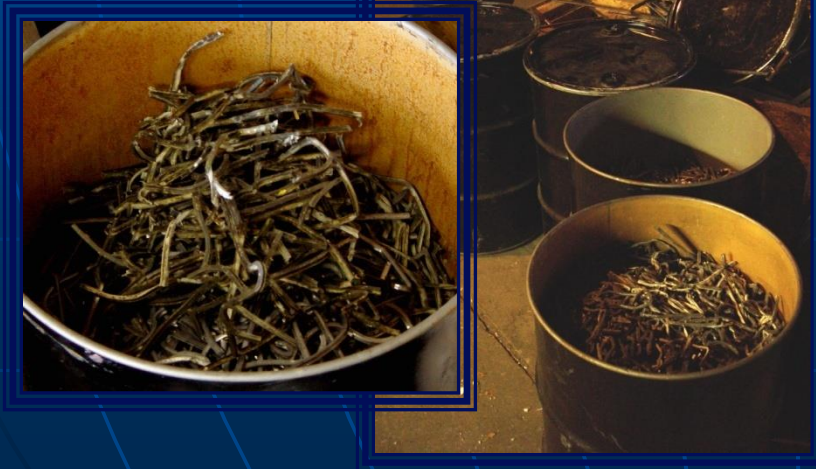
## SAFETY AND ENVIRONMENT

- The traditional glazing cement ingredient is lead oxide.
- Disassemble in soak tank to keep the lead oxide from being airborne and breathed by craftsman.
- Used water is stored and shipped to toxic waste water treatment facility
- Client is ultimately liable for proper disposal of lead.
- Passing the middle man (salvage companies) assures there is no mishandling. We have shipped 14,000 lb. of scrap lead came directly to the lead smelter in New York State in the past.
- This protects the studio and the client from very large E.P.A. fines for improperly disposing of lead.
